VIN	- Not Captured -	
Vehicle	- Unknown -	
License Plate	BDB9619 - TN	Odo: mi.

Vehicle Scan Summary · 8/8/2025, 11:46 AM

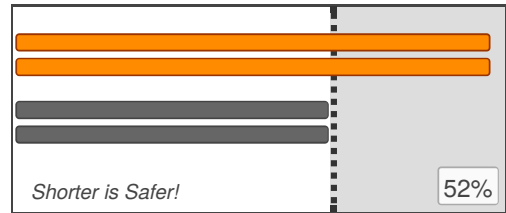
Braking Distance

(70 MPH - Wet Surface)

Shorter is Safer!

■ Your Tires

■ New Tires

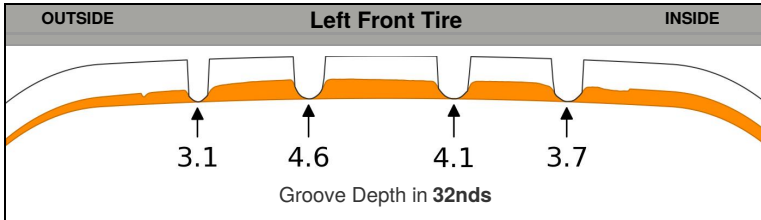
3.1 4.6 4.1 3.7

Groove Depth in 32nds

- Check for abnormal tire wear. See your service advisor.
- Check for accelerated outside wear on this tire. Consider a wheel alignment. See your service advisor.

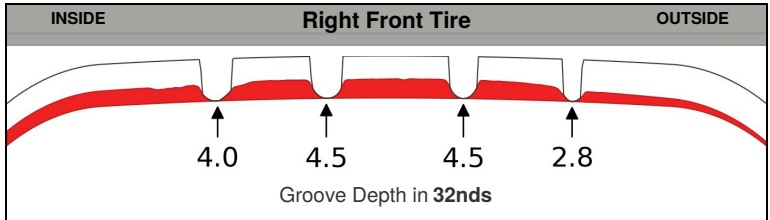
4.0 4.5 4.5 2.8

Groove Depth in 32nds

- Check for accelerated outside wear on this tire. Consider a wheel alignment. See your service advisor.
- The sample collected for this tire indicates the Tread Depth is NOT safe. Replacement is recommended today. See your service advisor.

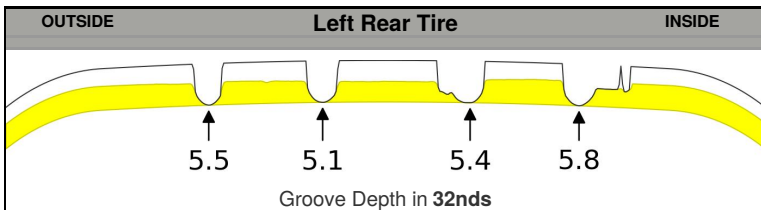
5.5 5.1 5.4 5.8

Groove Depth in 32nds

- The sample collected for this tire indicates the Tread Depth is safe, replacement not needed today. See your service advisor.

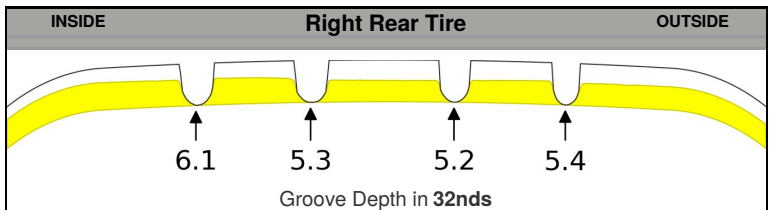
6.1 5.3 5.2 5.4

Groove Depth in 32nds

- The sample collected for this tire indicates the Tread Depth is safe, replacement not needed today. See your service advisor.
