Mercedes-Benz

Mercedes Benz at Long of Chattanooga
6039 International Drive
Chattanooga, TN 37421
(423) 855-3726
http://www.longco.mercedesdealer.com/
Scanned by: Mercedes Service

## Vehicle Scan Summary · 10/3/2024, 1:50 PM

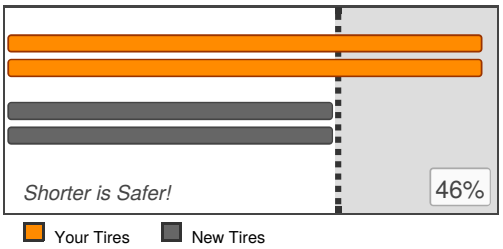
## Braking Distance

( 70 MPH - Wet Surface )
